# First Watch Special Edition

*Great ideas lead to safer, healthier workplaces -  
an innovative and proactive approach to prevention*

## About the Innovation Awards

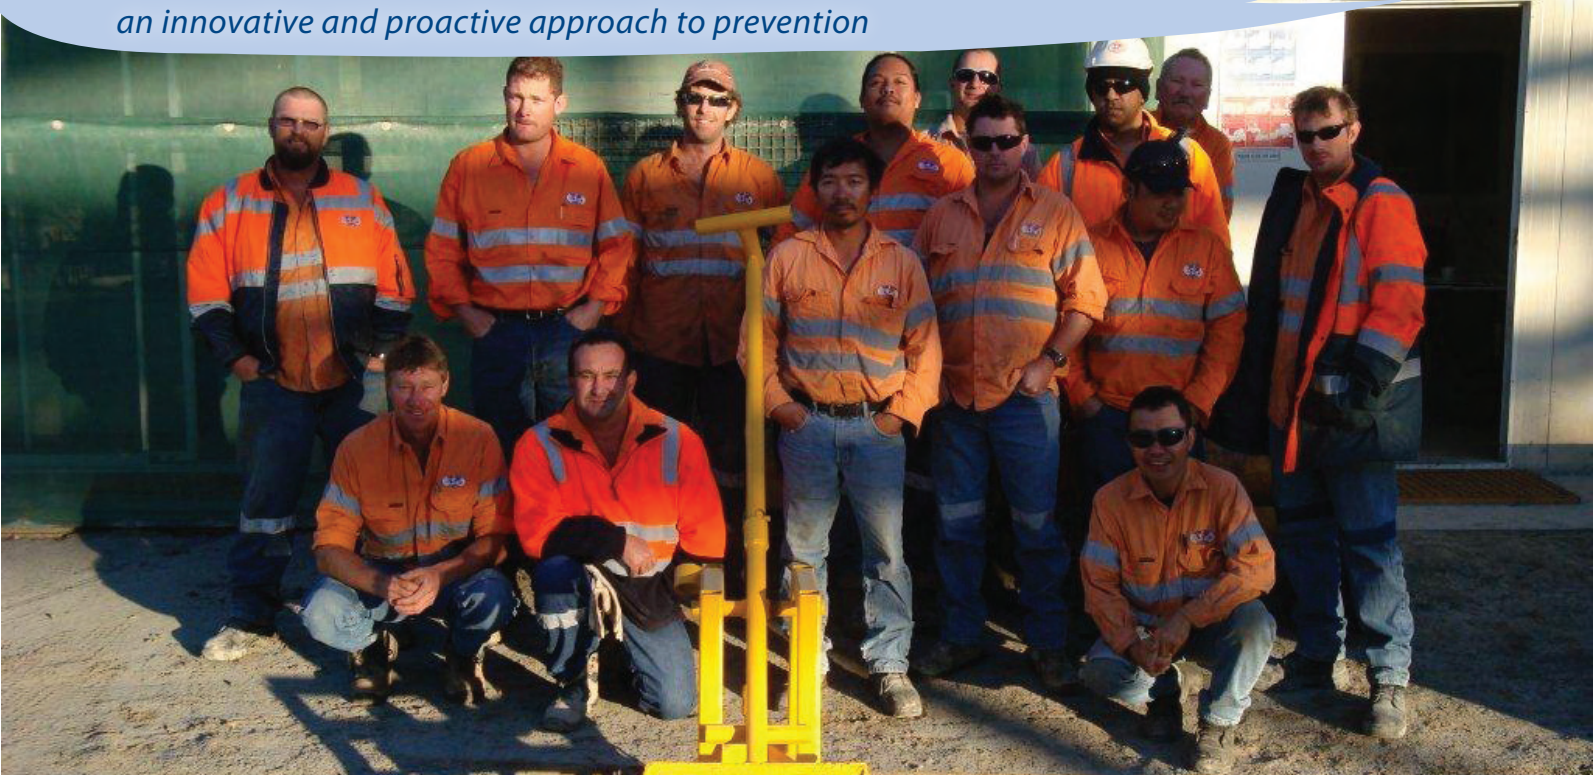
Crushing Services International – Gum Trolley

The new gum trolley device, developed by CSI's site manager and onsite workforce, allows lifting and positioning of the edge segments to be safely conducted by one person. The trolley is operated through an extended handle that requires minimal force. In addition to reducing risk of injury, the device saves time and reduces labour costs. As it is designed specifically for lifting and fitting the gums, there is also minimal risk of injury through misuse. It is compact in size, allowing it to be maneuvered easily.

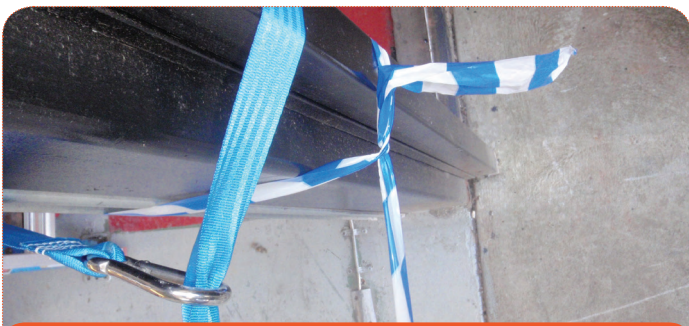
The difference of attaching ours to tying the plastic

The use of 75mm plastic tape is commonplace to identify hazards or cordon off areas subject to accident investigations. But the tape poses problems as it can be broken, is difficult to see at night and cannot be recycled. In searching for a solution, Modern Motor Trimmers conducted rigorous testing on a range of potential materials and settled on a UV-treated webbing with reflector material stitched to both sides.

In addition, sturdy D-shackles were added to provide strong anchor points and a retractable, geared hand winder added for ease of installation and removal. The barrier tape can be readily mounted on a wide range of anchor points, ranging from pillars and bag trolleys to vehicles. There are also many potential uses across other industries and applications including use by emergency services, crowd control and a broad range of other temporary barrier requirements.
